UNDERWATER BRIDGE INSPECTION REPORT

STRUCTURE NO. 73540

10TH STREET BRIDGE (MSAS NO. 101)

MINNESOTA DEPARTMENT OF TRANSPORTATION
UNDERWATER BRIDGE INSPECTION

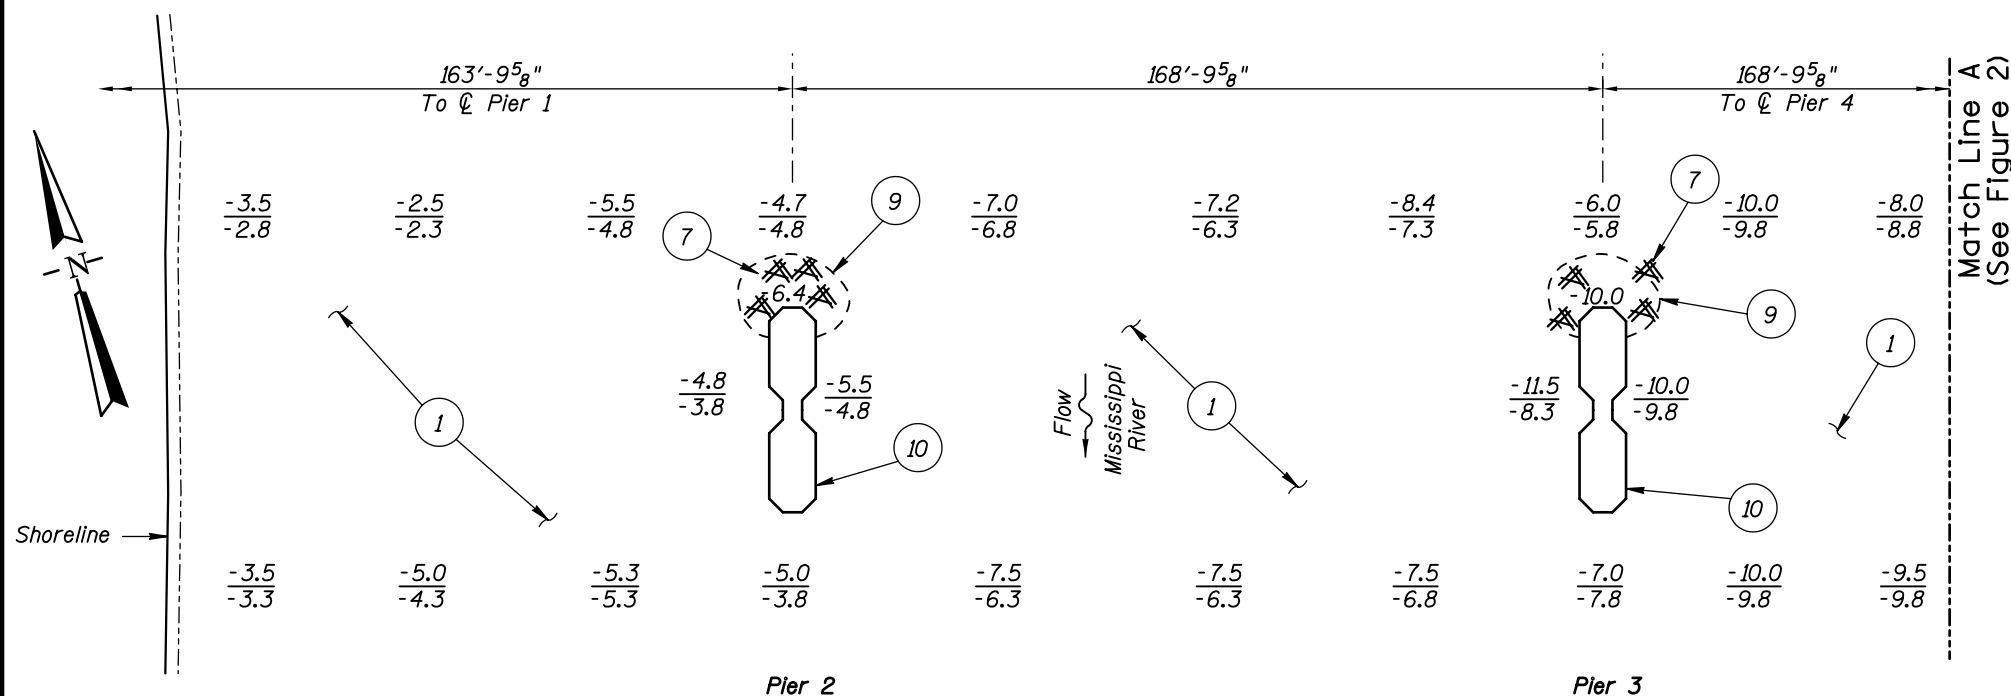
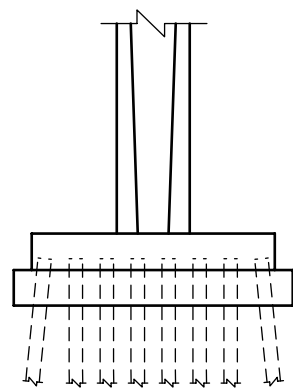
INSPECTION AND SOUNDING PLAN

- 1 The channel bottom material consisted of sandy gravel and random cobbles with a maximum probe rod penetration of 2 inches.
- 2 The channel bottom material consisted of loose sand with a maximum probe rod penetration of 2 feet at the upstream end of Piers 4 and 5.

- 3 Footing exposure was observed at the upstream end of Pier 4, extending 20 feet downstream on the west side of the pier and 18 feet downstream on the east side, with a maximum vertical face exposure of 2 feet at the upstream nose.

- 4 Footing exposure was observed at the upstream end of Pier 5, extending 8 feet downstream on both sides of the pier, with a maximum vertical face exposure of 3 feet at the upstream nose.

- 5 A vertical crack was observed along the centerline of the pier extending from 3 feet below the waterline to the top of the web wall with a 1/4 inch maximum width.

- 6 A crack was observed on the top of the west side of the footing extending to the center of the pier face with a maximum width of 1/4 inch.
- 7 A moderate accumulation of 18-inch-diameter and smaller timber debris was observed at the upstream end of Piers 2 and 3 extending from 5 feet below the waterline to the channel bottom.

- 8 A light accumulation of 2-inch-diameter and smaller timber debris was observed at the upstream end and along the east face of Pier 4.
- 9 Minor scour depressions, typically 5 foot in radius and 2 to 3 feet deep, were observed around the upstream ends of all the piers, resulting in footing exposure at Piers 4 and 5.

- 10 The submerged concrete of the piers and exposed footings was in good, smooth and sound condition.

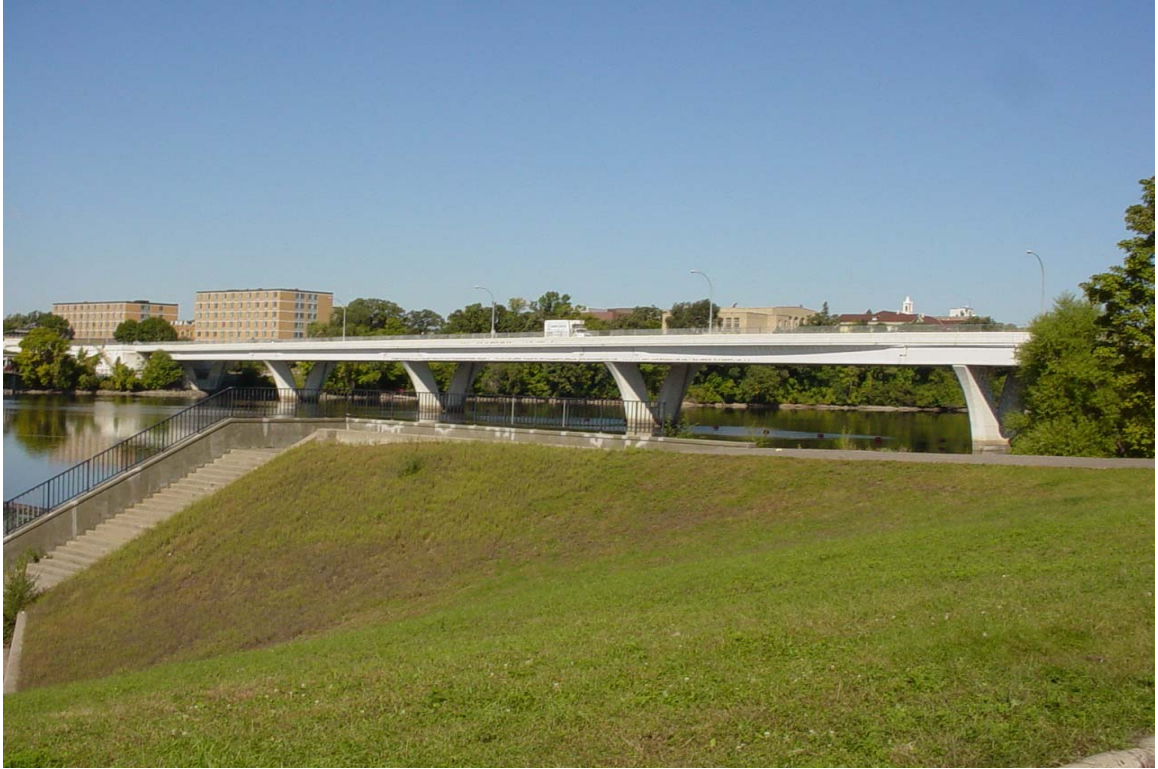
Photograph 1. Overall View of the Structure, Looking Northwest.

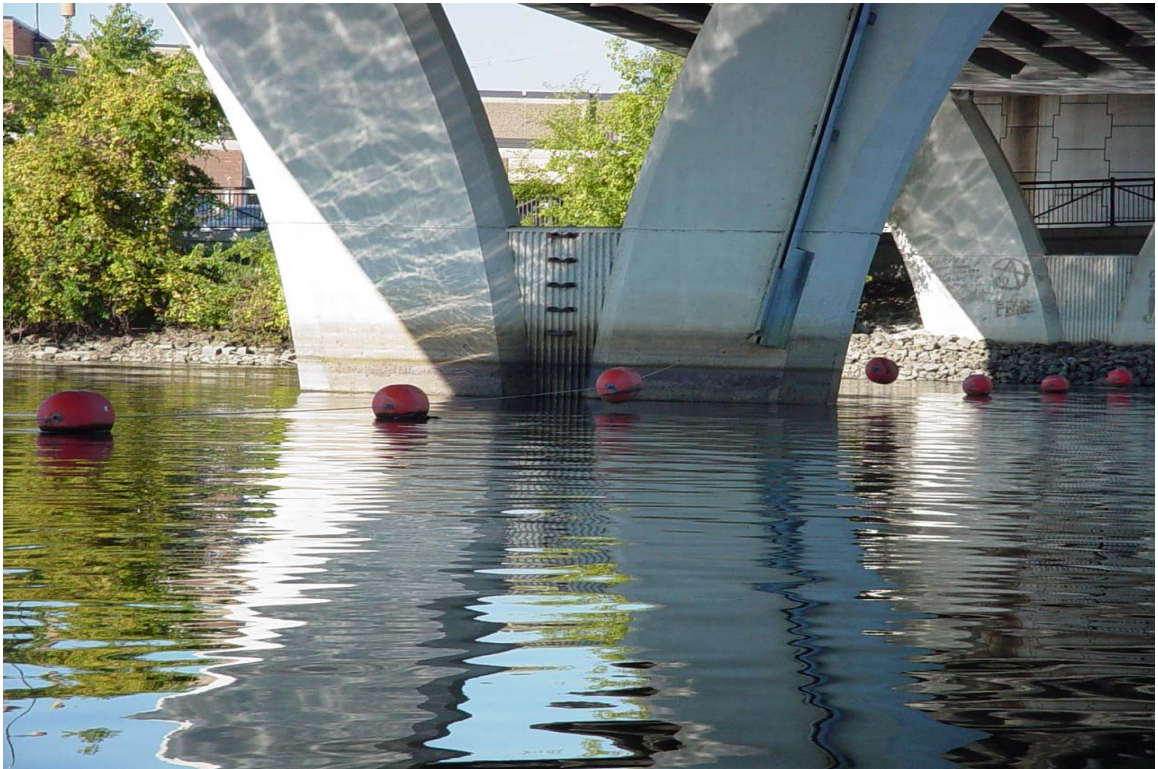
Photograph 2. View of Pier 2, Looking Southwest.

- (E) A light to moderate accumulation of timber debris was observed at the upstream ends of Piers 2, 3, and 4.

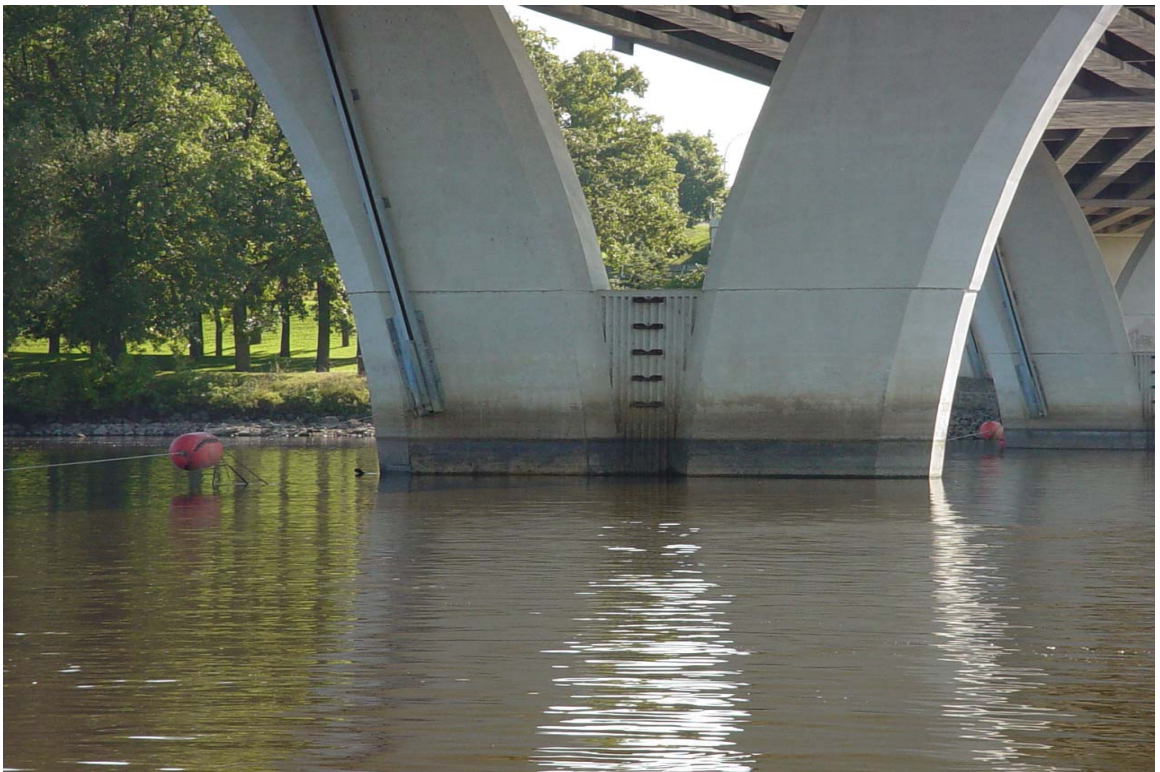
Photograph 4. View of Pier 4, Looking Northeast.

- (A) Footing exposure was observed at the upstream ends of Piers 4 and 5. The exposure at Pier 4 extended 20 feet downstream on the west side of the pier with a maximum vertical face exposure of 2 feet. The exposure at Pier 5 extended 8 feet to the downstream on both sides of the pier with a maximum vertical face exposure of 3 feet.

- (B) A 1/8 to 1/4 inch wide vertical crack was observed on Pier 4 extending from 3 feet below the waterline to the top of the concrete web wall at the center of the pier on both the east and west faces.

- (C) A 1/4 inch wide crack was observed on the top of the footing at the center of the west side of Pier 4, extending from the west edge of the footing to the face of the pier shaft.

- (A) Monitor the noted cracks during future inspections. If found to be progressing, consideration could be given to sealing and structurally mending the cracks at Pier 4 by epoxy injecting and/or patching at that time.
- (B) Scour screening assessment indicates stable rating, therefore, presently it is only necessary to monitor extent of scour and footing exposure during future inspections.
- (C) Reinspect the submerged substructure units at the normal maximum recommended (NBIS) interval of five (5) years.

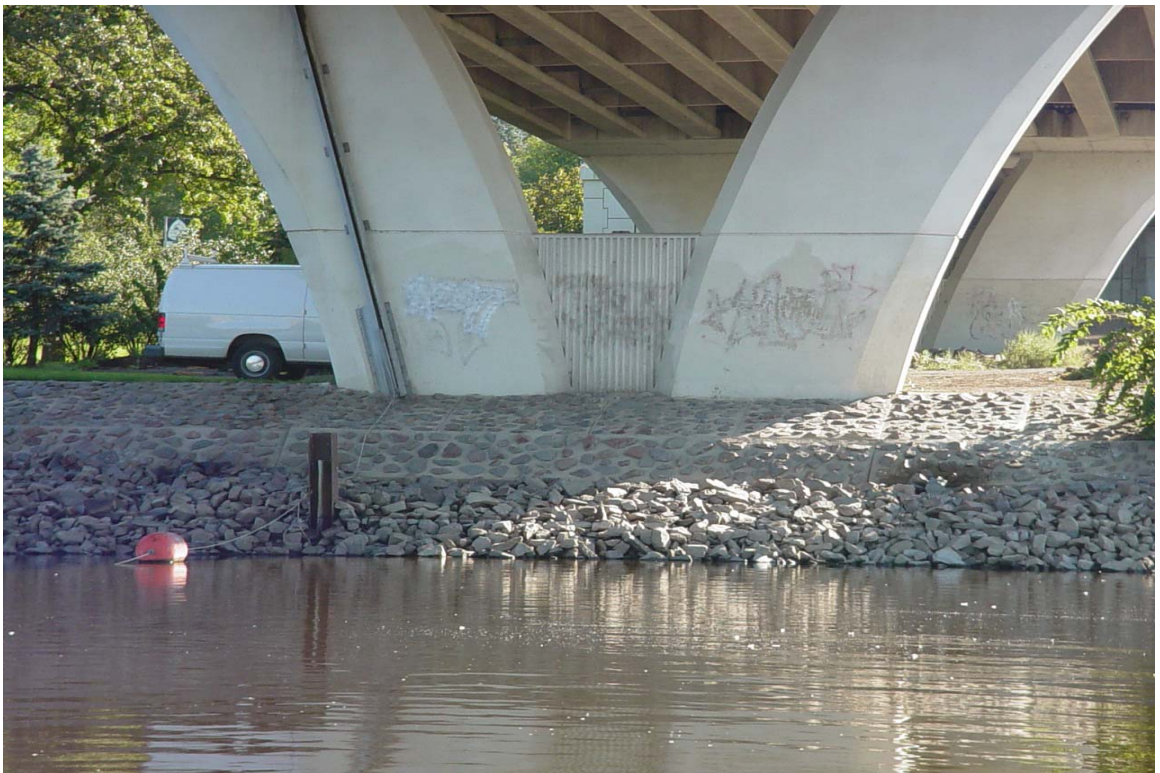
Photograph 6. View of Pier 6, Looking Northeast.
